# REFURBISHMENT OF DRINKING WATER SPLIT CASING PUMP

ID: 9628

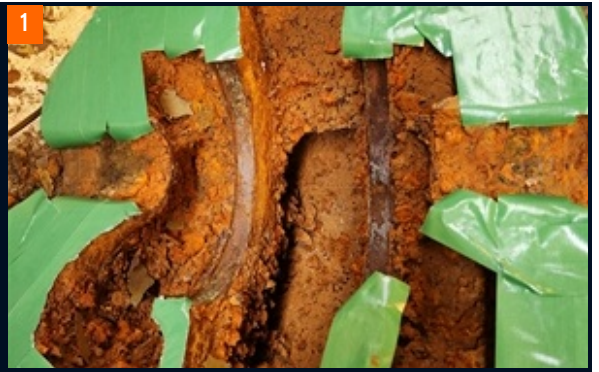
Customer faced corrosion and erosion in the casing of drinking water pump and it was unusable before Belzona repair.

1. Pump condition before application
2. Close up of corrosion damage
3. Pump after rebuilding and coating
4. Another angle shot after application
