# REPAIR AND PROTECTION OF CENTRIFUGAL SPLIT CASING PUMP

ID: 9630

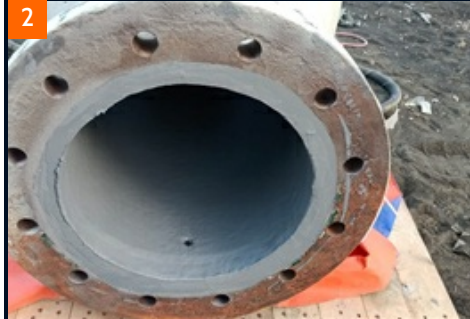
The pump faced erosion and corrosion of the pump casing, resulting in pitting damage across the internal surfaces affecting performance.

1. Pitting damage appeared after blasting
2. Damage repaired with the paste grade
3. Coating application to the cutwater
4. Coating application to the nozzle

Blasting was performed for surface preparation according to Instruction For Use. Belzona 1111 was used to fill pitting and rebuild the ring seat area using the forming technique with Belzona release agent. Finally 2-coat system of Belzona 1341 was applied according to Instruction For Use.
