# CORRODED ROTOR AND END COVERS

ID: 9636

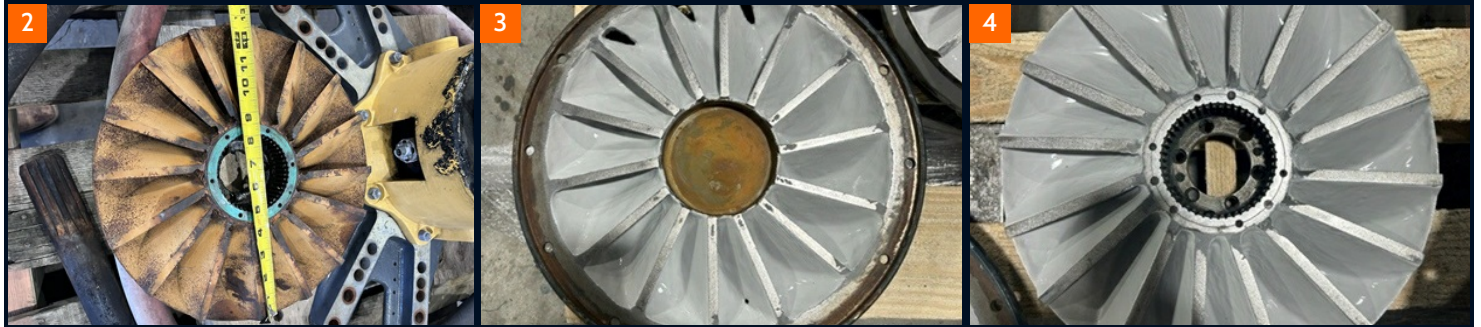
Rotor and end covers corroded due to harsh saltwater environment.

1. End covers before application.
2. Rotor before application.
3. Area rebuilt with Belzona 1111 and protected with Belzona 1331.
4. Second coat of Belzona 1331 applied.

Abrasive blasting was performed to create a bonding surface essential for Belzona 1111 to be applied.

Belzona 1111 (Super Metal)  
Belzona 1331
