# STRESS CORROSION CRACKED FILTER STRIPPER

ID: 9647

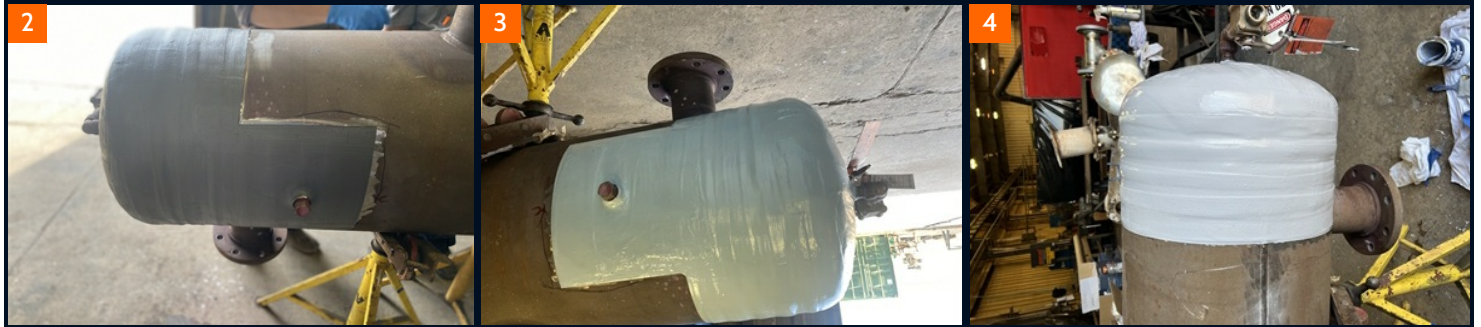
Charge Filter Stripper operating in excess of 200 degrees F. was suffering from Stress corrosion cracking.

1. Surface preparation of areas of repair, all identified cracks terminated as per system leaflet TCC-1
2. Application of 1511/ 9341 Reinforced system to bottom Head and extending 6" outside defect area.
3. Additional protection provided by application of additional 1593/9341 reinforced system.
4. Completion of 1593/9341 reinforced system.

TCC-1 procedure was used to address all identified cracks. Surface preparation was carried out using grinder and final profile achieved utilizing MBX surface profiling tool. Upon completion of application the unit was force/poste cured as per Product manufactures recommendations in order to return to service requirements within 24 hrs.
