# SEA WATER STRAINER INTERNAL COATING

ID: 9658

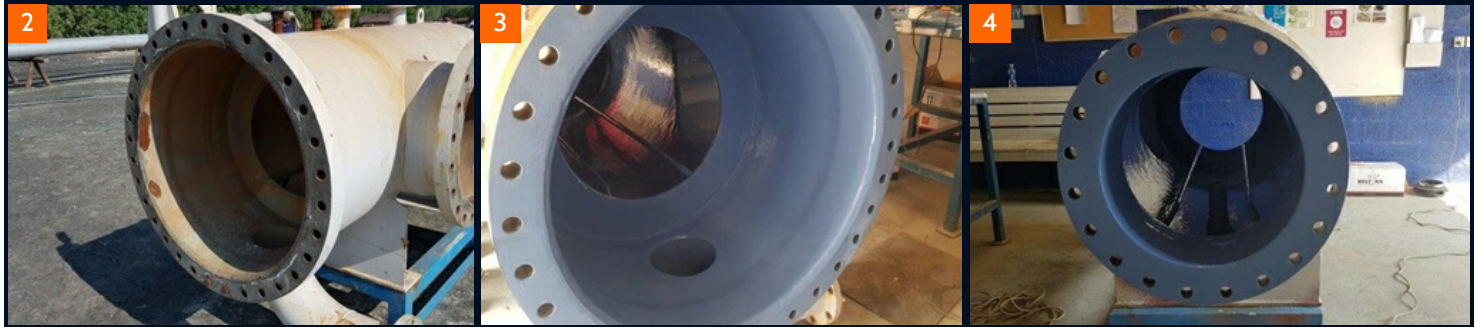
existing coating delaminated and localized corrosion where found on several areas on the substrate

The existing coating on the sea water strainer failed at many locations which caused localized corrosion on multiple locations which lead to deep pitting and corrosion.

1. Sea water strainer suffered corrosion on the internal surface
2. A closer look at the corroded sea water strainer
3. The internal surface of the strainer was rebuilt with Belzona 1111 (Super Metal) and overcoated with Belzona 1341 (Supermetalgilde)
4. Complete application to restore the strainer

1. Remove the existing coating.
2. Rebuild the surface with Belzona 1111 on all the pitted areas
3. Overcoat the internal surfaces with Belzona 1341 (Supermetalgilde)
