# BUNKER FUEL TRANSFER PUMP REPAIR

ID: 9776

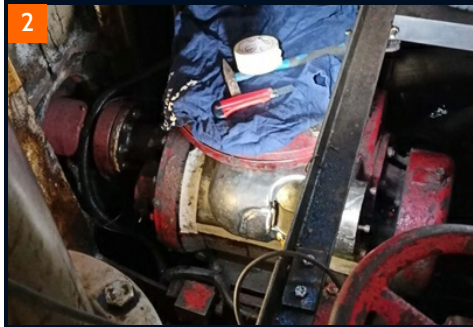
The traditional welding method has failed on a fully propagated crack, resulting in crude oil leakage from the pump bypass valve.

1. Initial Damage.
2. Prepared surface.
3. Belzona Super Metal application.
4. Complete Repair.
