# SEA WATER PUMP HOUSE PIPE REPAIR

ID: 9812

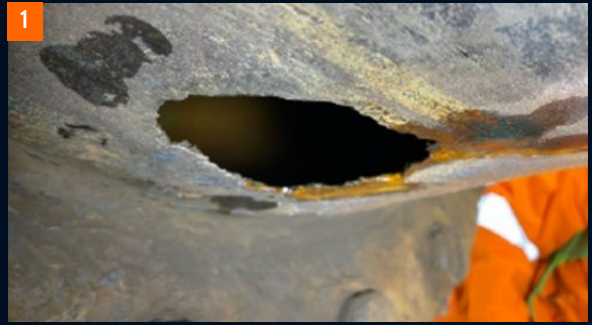
Severe erosion - through wall defect

1. Through wall defect on pipe due to severe corrosion
2. Surface area was prepared to minimum surface profile using power tools
3. Plate is bonded over the defect area and clamped in place
4. The entire area is wrapped with Belzona 1111 and Belzona 9341
