# EXTERNALLY CORRODED PIPE RESTORED AND STRENGTHENED

ID: 9813

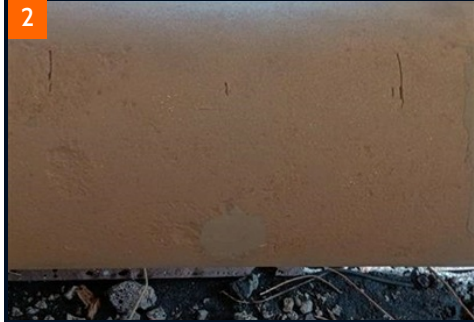
Customer identified an area of corrosion on their JP-51 pipeline, resulting in reduced wall thickness. The affected section was believed to have thinned to 5.31mm

1. External corrosion had caused deep pitting in the pipe
2. Belzona 1111 is applied to prepared surface to bring back to profile
3. Belzona 1981 SuperWrap II system has six layers applied and consolidated with tape
4. Finished application, restoring integrity and increasing strength to pipe
