# FLOUR MIXER REPAIR

ID: 9820

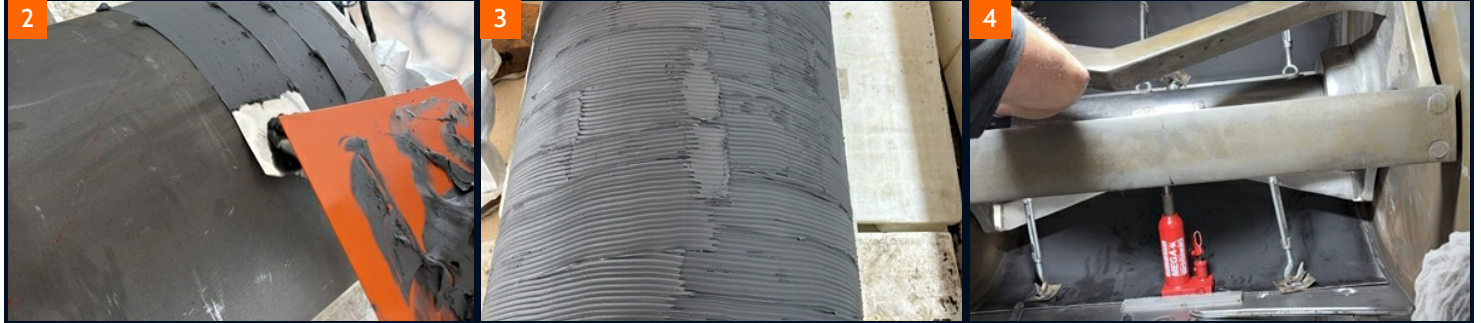
The flour mixer experienced a thin-wall effect caused by continuous surface abrasion from the flour, compromising its structural integrity over time.

1. The surface on the patch and mixer were prepared using the high-performance rotary power tool, ensuring optimal adhesion and finish.
2. Super Metal was applied to both the patch surface and the mixer, delivering a durable, high-performance bond.
3. A uniform, homogenous application was achieved across both surfaces
4. The patch was cold bonded and held securely in place until full curing was achieved, ensuring a strong and lasting repair.

Belzona provided a cost-effective repair solution for the flour mixer, completed in a fraction of the time and expense of traditional methods.

The repair was carried out in full compliance with the TCC-1 System Leaflet guidelines, ensuring a reliable and standardized application.
