# COMPLETE REHABILITATION OF FIRE PUMP

ID: 9832

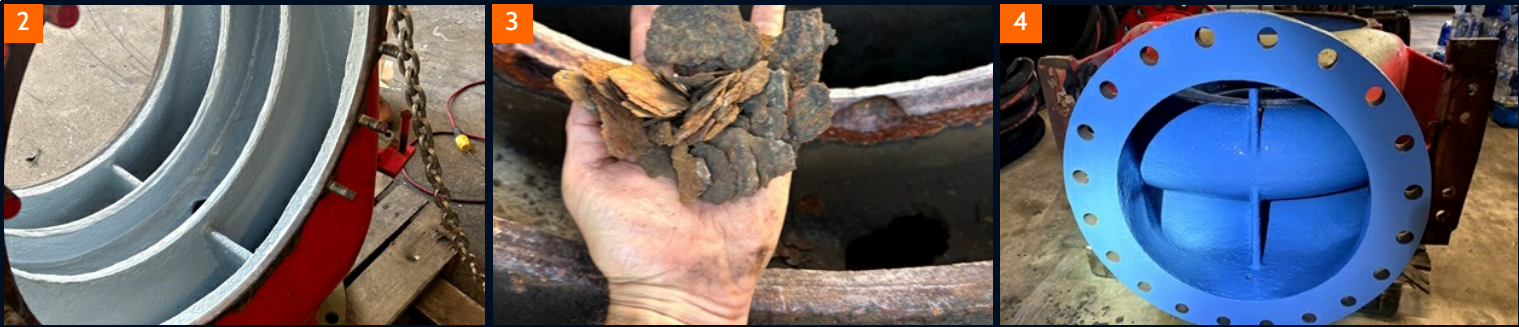
The customer was facing severe internal corrosion on their fire pump casing, with extensive material loss, flaking rust, and erosion damage. Several areas showed wall thinning and through-wall defects, compromising the structural integrity of the equipment. The pump was no longer reliable for emergency operation, posing a safety risk to the vessel.

1. Initial condition of the fire pump casing before repair. Severe internal corrosion, wall loss, and surface damage are visible, requiring structural rebuilding and protective coating.
2. Restored fire pump casing after application of Belzona 1121 for rebuilding and two coats of Belzona 1341 for internal protection and hydraulic efficiency. The light grey topcoat indicates the completion of the first protective layer.
3. Large flakes of rust detached from the internal surfaces of the fire pump casing, highlighting the severity of corrosion and the urgent need for rehabilitation."
4. Fire pump casing fully rebuilt and coated. Final coat of Belzona 1341 Blue applied to improve hydraulic efficiency and provide long-term protection against corrosion and erosion.

The internal surfaces of the fire pump casing were blasted to ensure proper mechanical adhesion. Surface cleanliness was verified, and Belzona 9111 was used to remove contaminants. Belzona 1121 was applied using applicator tools to rebuild areas with wall loss and restore the original geometry. After curing, two coats of Belzona 1341 were applied by brush, the first in grey and the second in blue to ensure full coverage and visual confirmation of coating integrity.
