# REVERSE OSMOSIS RO MEMBRANE HOUSING END CAP REPAIRS

ID: 9864

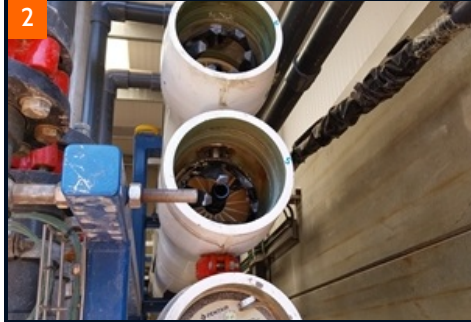
Two of the end caps on a large industrial reverse osmosis membrane housing had split, leading to a drop in pressure, big leaks and an efficiency drop in the process. The cracks needed to be fixed.

This was attempted by gluing collars of the outlets on the endcaps, which was a vain attempt and simply didn't work.

1. Showing porosity to glued collar, still allowing system pressure drop
2. End cap receptor in RO Membrane housing
3. Applying Belzona 1212 to the 2 interfaces around the repair collar, previously glued, leading to a failed repair
4. Both interfaces to the end cap fully sealed and ready to be refitted into the membrane housing
