# CONCRETE STITCHING TO DAMAGED GEARBOX PLINTH

ID: 9875

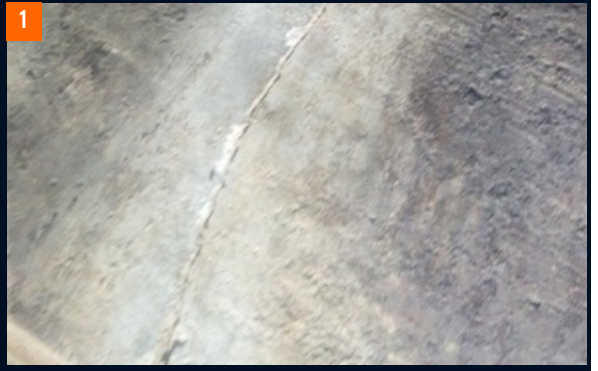
Following the stalling of a very large Ball Mill, the kinetic energy was transferred back to the gear box through the drive assembly. One this energy hit the gearbox, the gearbox kicked back and broke the 10" concrete plinth which the gearbox and drive motor were bolted to, some 30' in the air, above the ground floor  
Structural engineers were consulted, following the advice from the Belzona Area engineer and it was decided that Concrete stitching would provide the solution

1. Showing crack to plinth
2. Showing crack on opposite side of plinth
3. Cracks from above
4. Part way through repairs and concrete stitching, using experienced contractors and Belzona 4151 resins

Rake out any loose and friable and vacuum.  
All target areas to have Belzona 4911 applied as per Belzona 4000 series "Instruction for Use" sheets  
Seal the end of the crack with Belzona 4111  
Seal the horizontal cracks at distances of 8" to 10", leaving small gaps for the installation of injection ports  
Bond the injection ports on to the gaps between the repairs  
Using Belzona 4151 in a cartridge, stat at the sealed end of the crack and inject the Belzona 4151 into the first port until it appears at the next port in line  
Continue this process until all the crack has been completely filled  
Remove the ports and complete the seal over the gaps to complete the injection repair
