# BELZONA OPENS THE DOOR

ID: 9919

**PROBLEM**  
Door handle coming off.

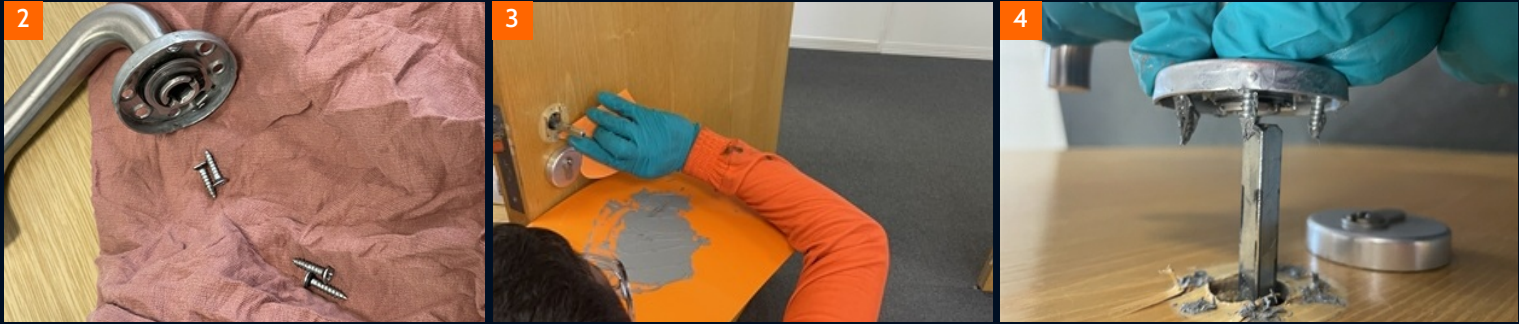
**APPLICATION SITUATION**  
The screws on the door handle had pulled and ripped the wood, due to finance team's enthusiasm to get to work. Having a screw loose, or more than one, is not good for such a critical operating area, so it was important for the site facilities team to respond quickly to ensure the internal customer was happy and the facilities team would be paid at the end of the month.

- PHOTOS**
1. The damaged door
  2. Belzona 9411 was applied to the screws, and importantly, to the door handle so that it could be removed in future if needed
  3. Belzona 1111 was worked into the holes in the door, as well as on the screws
  4. The door was reassembled, and screws tightened. The wet-out of the screws here was not perfect, however, the Belzona 1111 in the hole and on the screw would wet out on assembly

**APPLICATION METHOD**  
The Door handle, and screws, were coated with 9411 and allowed to dry for 20mins. Belzona 1111 was mixed and worked into the wood of the door, and some was also put on the screw threads, before the unit was reassembled and allowed to cure. This used the ENC2 stripped thread method.
