# CAVITATION REPAIR OF RUNNER BLADES USING BELZONA SOLUTIONS

ID: 9932

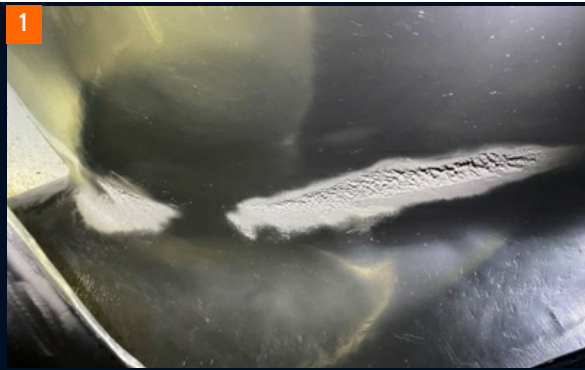
A hydroelectric facility was experiencing severe cavitation damage on the runner blades of a unit. The affected areas showed significant material loss, particularly at the blade-to-band transition zone on the suction side, where cavitation effects are most aggressive. This wear threatened operational efficiency and long-term equipment integrity.

1. Section of the runner affected by cavitation
2. Substrate after surface preparation via abrasive blasting
3. Application of 1st coat of Belzona 1341
4. Completed repair with 2141 over the most critical areas
