# DYNO MILL WEAR RING REPAIR

ID: 9954

## PROBLEM

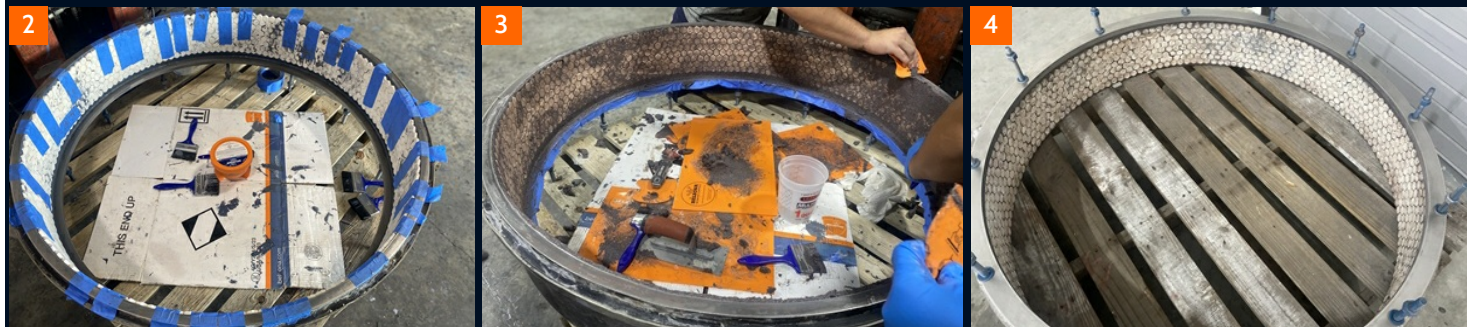
The internal diameter of a 40" Dyno Mill wear ring exhibited significant wear and erosion in multiple sections. The high abrasion environment within the mill caused degradation, compromising performance and longevity. A long-term, abrasion-resistant solution was required to restore integrity and extend service life.

1. Before Application
2. Applying Belzona 9811 alumina tiles
3. Belzona 1812 Grout
4. Finished application

AAS proposed a full Belzona rebuild and protective liner installation: Surface preparation was completed via abrasive blasting.

Damaged/worn areas were repaired and rebuilt using Belzona 1311 (Ceramic R-Metal) to restore original geometry.

Once cured, the entire wear ring ID was overlaid with Belzona 9811/1812 alumina ceramic hex tile system for maximum abrasion protection.
