# BELZONA REPAIRS SECTIONS OF COOLING WATER SPOOLS

ID: 9958

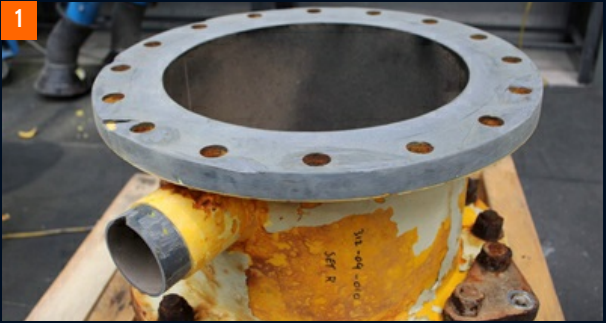
The spools were removed by cutting around the sealing face joints, severing the bolts and causing damage to the sealing surfaces in the process.

In addition to this damage, several stabblings have either completely failed or have been previously repaired in situ over the years but are no longer performing as required

1. Water cooling spools arrive with damage to sealing faces and stabblings
2. The surface areas are prepped to a minimum surface profile for the repair solution
3. Belzona 7311 is applied and Belzona Superwrap II is applied to add strength and integrity
4. The cooling spools have been reprofiled and repaired, ready to be reinstated
