# BELZONA PROTECTS CITIES WATER PUMPS

ID: 996

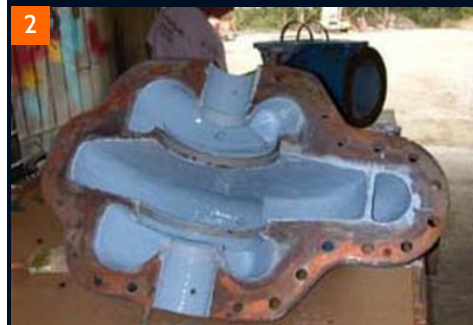
Failure due to high cavitation caused by bad suction conditions that could not be changed.

1. Lower casing half before application
2. Lower casing half, completed
3. Impeller with casing ring shimmed and ready to refit the casing ring seats
4. Rotor set in lower casing half, ready to install the top casing

Application carried out in accordance with Belzona Know-How System Leaflets CEP-3 and CEP-5.
