# FIBERGLASS HEADERS REPAIRED AND RESTORED USING BELZONA 1813

ID: 9982

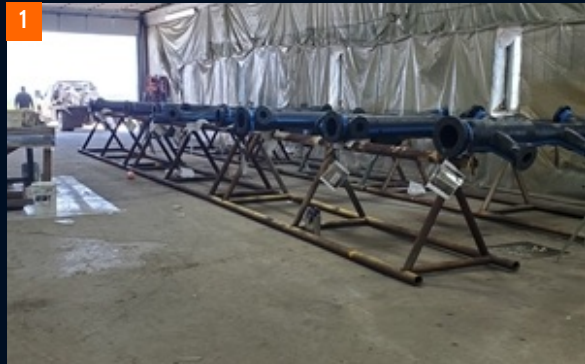
Pre-scrubber tank with fiberglass headers that spray internally. The spray nozzles get plugged and changes direction of spray and wears out the fiberglass on top of headers badly, severe wear.

1. Fiberglass headers ready for manual preparation. These headers were taken off site and delivered to contractor's shop.
2. Contractor initial mixing of Belzona 1813.
3. Contractor applying Belzona 1813.
4. Belzona 1813 applied to fiberglass headers.

The fiberglass was manually prepped using grinders per Belzona spec and letter, cleaned using MEK cleaner and troweled on with Belzona 1813.
