IN-SITU SEALING OF SF6 GAS LEAK ON GIS EQUIPMENT USING BELZONA SF6-FIX SYSTEM

ID: 10232

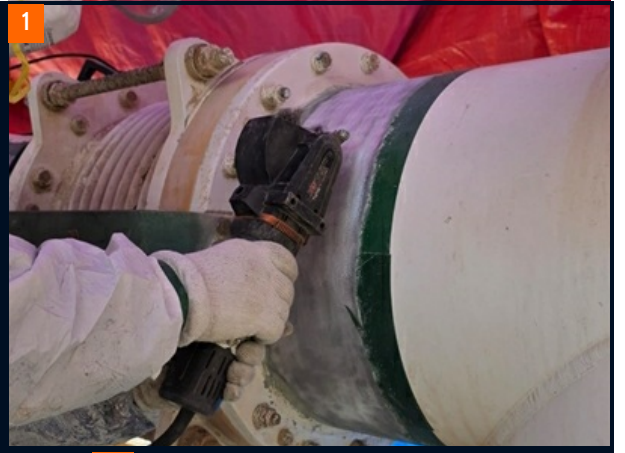
1. Surface preparation of bond areas in accordance to SSPC-SP 11 using MBX Bristle Blaster.
2. Application of Belzona 7311 on breather membrane.
3. Application of Belzona 9371 reinforcement sheets wet out with Belzona 1983 SuperWrap II resin.
4. Application of Belzona 5721 UV-resistant topcoat.

The repair followed Belzona SF6-Fix system leaflet GSS-14. Bond areas were prepared to SSPC-SP 11 standard using an MBX bristle blaster and cleaned of contaminants. Breathing tubes were installed on each repair using 3D-printed holders, with backing rod placed between bolt gaps to create a level surface.
