# BELZONA SEALS SF6 LEAK IN HYDROELECTRIC POWER STATION

ID:1

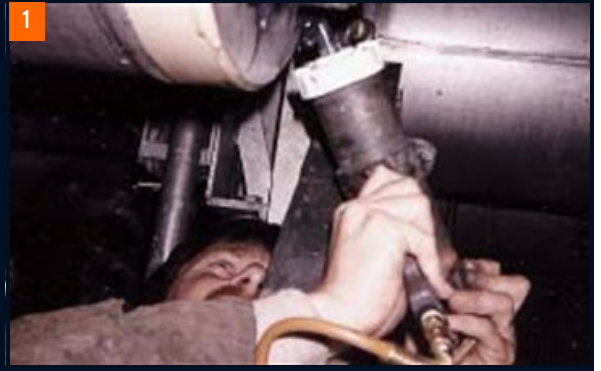
The SF6 dielectric gaseous insulator was leaking from the flange.

Flanges of SF6 (sulfur hexafluoride) buss bars.

1. Belzona 2211 (MP Hi-Build Elastomer) was injected between flanges to fill the gap.
2. Completed application.
3. Various leaking flanges were sealed

The application was carried out in accordance with Belzona Know-How Leaflet GSS-4.
