# BELZONA KEEPS BEET SLICER RUNNING

Bearing failure damaged beet slicer shaft

Beet slicer shaft

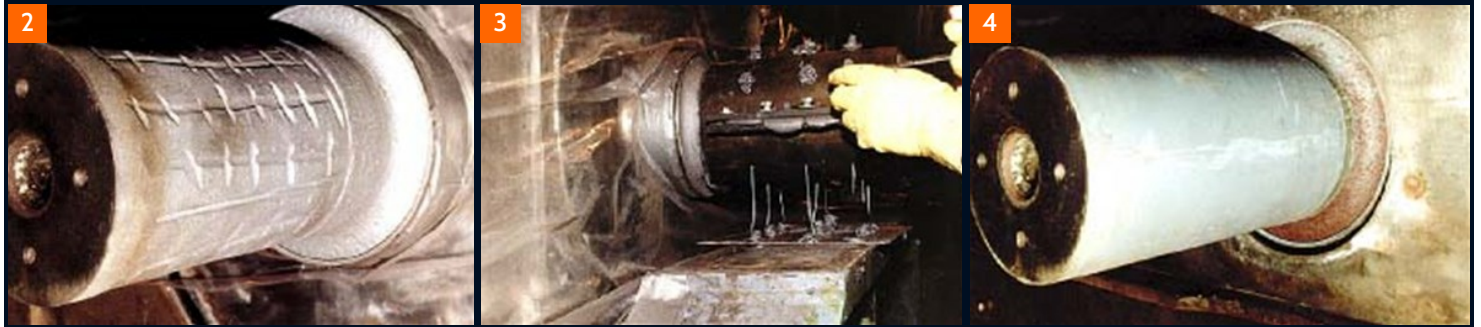
1. View of damaged shaft .
2. Application of Belzona 1111 (Super Metal).
3. Use of a former to rebuild shaft.
4. Completely rebuilt shaft.

The application was carried out in accordance with Belzona Know-How Leaflet MPT-2.

Repair allowed customer to save time and money by avoiding disassembly of machinery.
