# BELZONA REFORMS MAIN ENGINE LINER LANDS AND CORRODED COOLING WATER PASSAGES

ID: 100

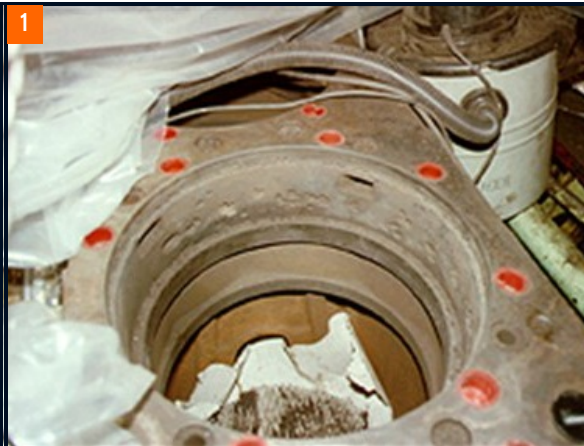
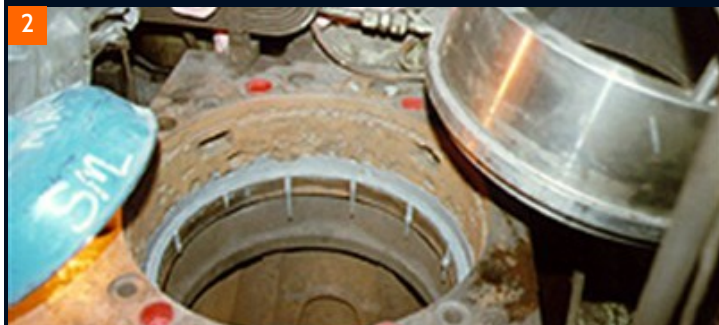
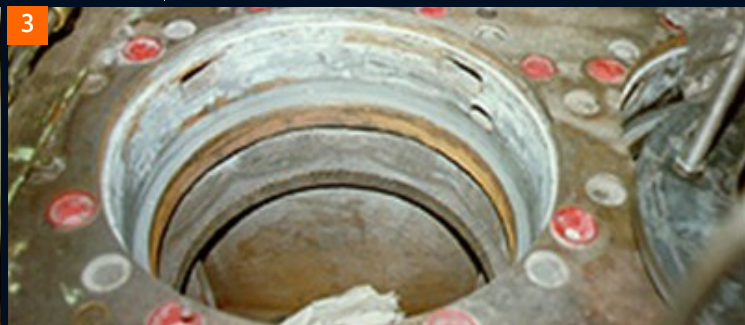
## PHOTOS

Corrosion in water cooled top land area of engine block.

1. After grit blasting the degree of corrosion clearly evident
2. Lower land reformed
3. Cylinder rebuilt awaiting final finishing

Application was carried out in accordance with Belzona System Leaflet ENC-4, using formers to reconstruct the two cylinder liner lands in each cylinder.
