# GAS DEHYDRATION PLANT HEAT EXCHANGER

ID: 10001

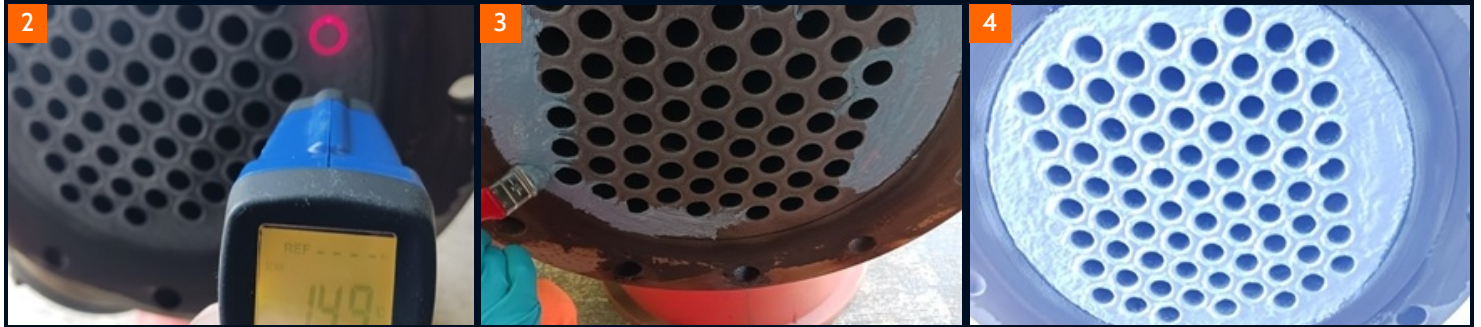
## PHOTOS

The customer found the tube sheets we're showing signs of corrosion and pitting due to the equipment was operating with no coating protection for many years and wanted protection to save the life of the equipment.

1. Tube sheet preparation complete grit blasted and cleaned
2. Substrate Temperature checked before starting application
3. Application of Belzona 1391T Blue
4. Application of Belzona 1391T Grey completed

The customer decided to use the Belzona products, first the tube sheets were grit blasted and cleaned, pitting was found to be minimal so no rebuilding was required only two coats of Belzona 1391T was required.
