# BELZONA SOLUTION FOR IN-SITU SHAFT REPAIR AT A POWER STATION

ID: 10002

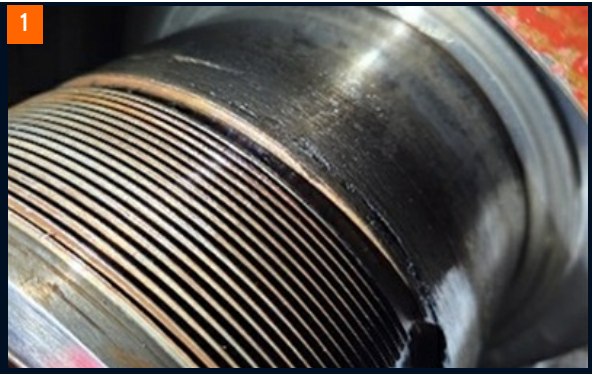
Shaft had suffered damage due to a spun bearing in service, leading to reduced performance and efficiency in operations.

1. Damage on shaft caused by a spun bearing in service
2. Preparation for shaft repair in situ
3. Belzona 1111 (Super Metal) was applied to restore the surface without the need to disassembling the equipment
4. Belzona 1111 (Super Metal) was left to cure and machined to original dimensions.
