# HISTORICAL RAILWAY CARRIAGE IS REVAMPED WITH A WATERPROOF MEMBRANE

ID: 10003

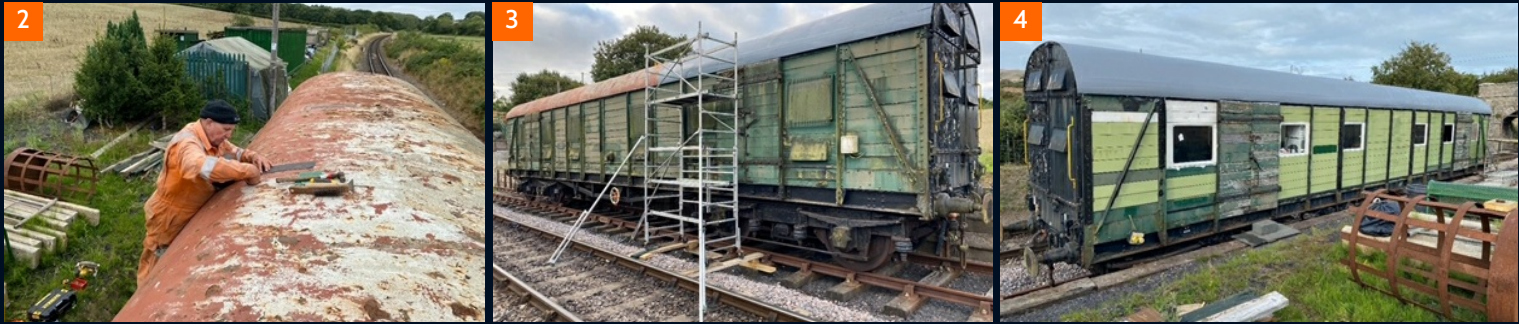
**PHOTOS**

A historic train carriage was suffering with external corrosion to the roof due to age and constant exposure to the elements.

1. Historic train carriage suffering from external corrosion
2. Debris is cleared and repairs are performed prior to application
3. Belzona 3111 is applied to the roofing area
4. Completed application, restoring integrity to roof

Once the roof has been cleared of all debris and prepared to minimum surface profile, Belzona 3921 as a general surface conditioner. Then, two coats of Belzona 3111 was applied to a reinforcement sheet to cover the train roof.
