# REPAIRS TO CORRODED INTERNAL SEALING FACES AT A PAPER MILL

ID: 10004

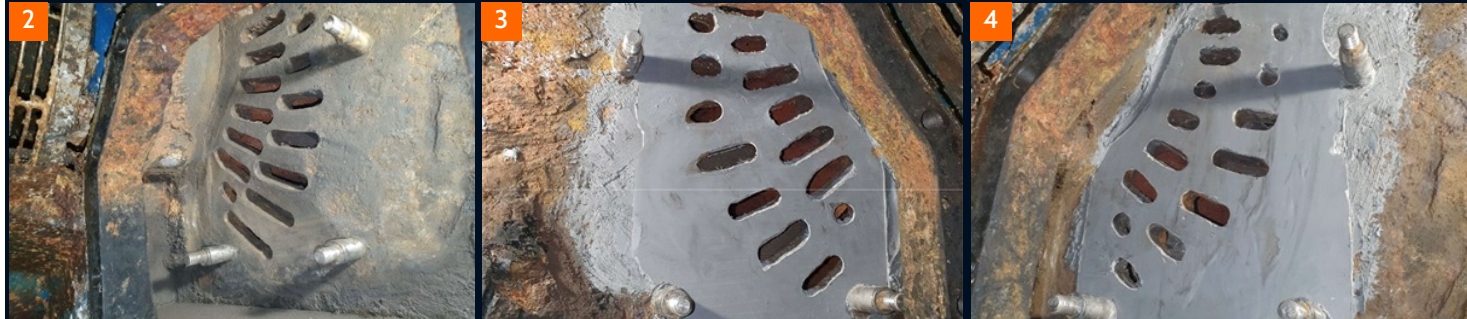
The customer had severely corroded sealing faces. Due to difficult with access, grit blasting was not an option and there was only a very short window of time to carry out any repairs. Customer required a long lasting permanent solution to the issue.

1. Heavily corroded sealing face.
2. Surface preparation carried out and area degreased
3. Former plate applied to defective area and Belzona 1311 allowed to cure
4. Sealing face formed at drive and non-drive end.

The area's were degreased and then wetted out using Belzona 1161 Super UW-Metal (Surface tolerant product) and allowed to cure.

The surface was then lightly abraded and then wetted out with Belzona 1311 Ceramic R-Metal.

Belzona 1311 was then applied to the former plates which had been coated with Belzona 9411 Release Agent, and then put up against the worn faces and allowed to cure.
