# SLURRY LINE LEAK REPAIR – COLD-APPLIED COMPOSITE SOLUTION AT CEMENT PLANT

ID: 10007

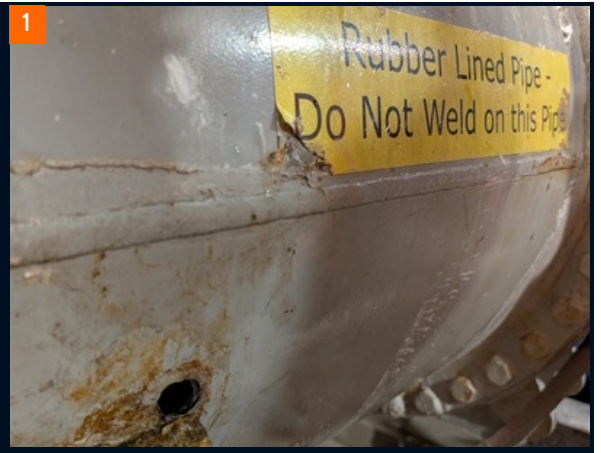
A rubber-lined slurry pipe inside a cement plant has developed an approx 1-inch diameter hole that has penetrated through the wall, resulting in an active leak of abrasive slurry. Welding was not an option due to the presence of internal rubber lining. Pipe was part of a critical production line, requiring a fast, strong, and reliable repair to avoid extended downtime.

1. A hole in a pipe before the application.
2. The surface has been prepared for the application
3. Rebuild with Belzona 1161 with 9341 mesh
4. Strengthening the repair with Super Wrap II with Belzona 1984
