# APPLICATION OF ANTI-SLIP SURFACE ON MILLENNIUM BRIDGE CONTROL ROOM

ID: 10008

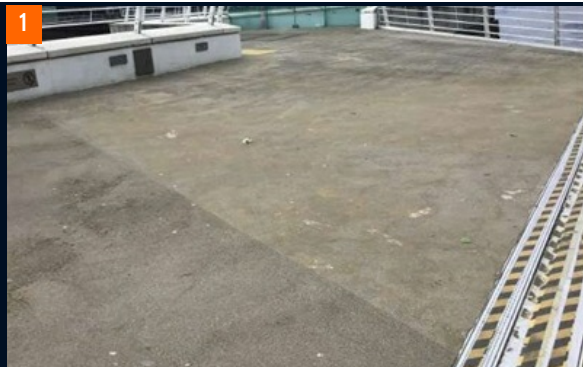
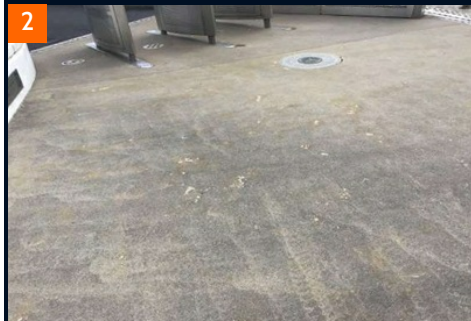
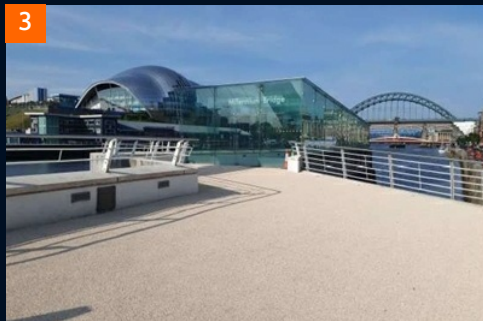
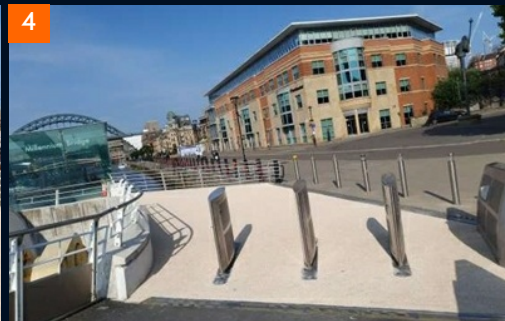
The customer was faced with consistent repairs required to maintain the footpath of the bridge.

Customer had been doing localised repairs to sections of the bridge. Previous repairs of Belzona 5811 had proven successful and so customer wished for a single solution that would eradicate the need for localised repairs and offer a long term solution.

1. Area that required consistent localised repairs
2. Path was power washed to remove debris
3. 1mm of Belzona was applied and blended with aggregate
4. Long term solution of anti-slip flooring was completed within strict time restrictions

The area was power washed prior to application. Belzona 5811 was applied at approximately 1mm thick and blended with aggregate to match existing path colour.
