# BELZONA PROTECTS BALL MILL BRACES

ID: 10009

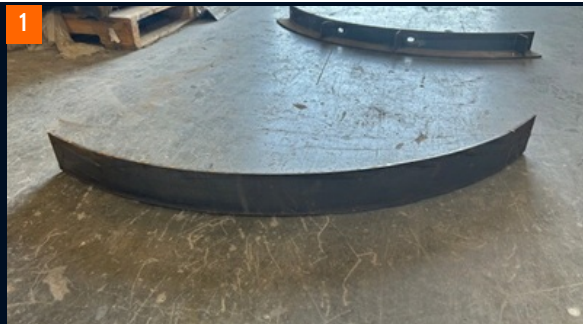
Customer was having high erosion on the braces supporting a ball mill handling Barite. Due to the high velocity and operating temperature of 300F, the Barite powder in the air was degrading the braces to no use within 2-3 months.

1. New upper and lower braces at customer location.
2. Braces blasted and prepped for application at Belzona/AAS location.
3. First coat of Belzona 1331 applied.
4. Second coat of Belzona 1331 applied and final product.
