# 35 YEAR OLD BELZONA BUILDING REPAIR

ID: 1001

College building balcony edges and rail supports.

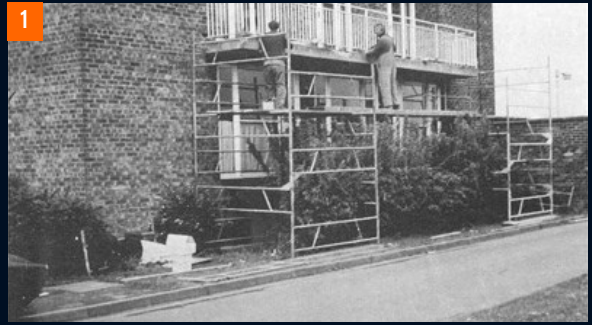
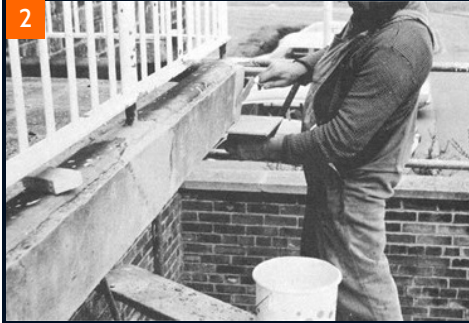
The balcony edges were spalling and the balcony rail supports were eroded-corroded.

The original repair being carried out in 1981  
A section of the original repair in 1981  
The repair area in February 2008  
The balcony in picture 4 after 35 years in service

Application was carried out in accordance with Belzona Know-How System Leaflet RPA-2. Corroded tubular rail supports were cut away and steel bars glued into remaining tubular supports with Belzona® 1111. Spalled concrete then rebuilt encapsulating the new steel supports.

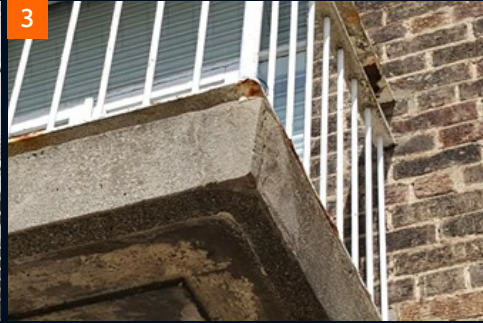
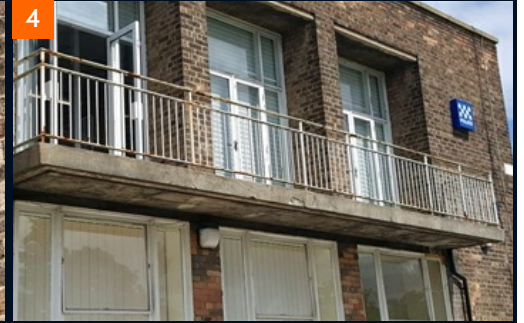
As shown in the photographs, the Belzona repair is still in perfect condition in 2016, over 35 years after the original application.
