# END SUCTION POTABLE WATER PUMP REFURBISHMENT

ID: 10012

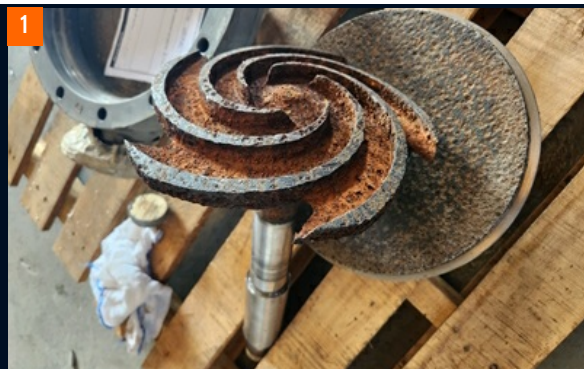
Heavy corrosion and erosion were observed on the pump components due to continuous water contact.

1. An impeller suffered corrosion from prolonged exposure to water
2. Eroded pump component required immediate solution
3. Pump impeller rebuilt with Belzona 1111 (Super Metal) and overcoated with Belzona 1341 (Supermetalglide)
4. Belzona 1341 (Supermetalglide) used on pump component for repair and improving pump performance

Application of Belzona 1111 (Super Metal) was carried out to restore the surface of the pump components prior to the application of Belzona 1341 (Supermetalglide) for further protecting the equipment and enhancing the pump performance.
