# PARTICULATE FILTER VESSELS INTERNAL COATING

ID: 10013

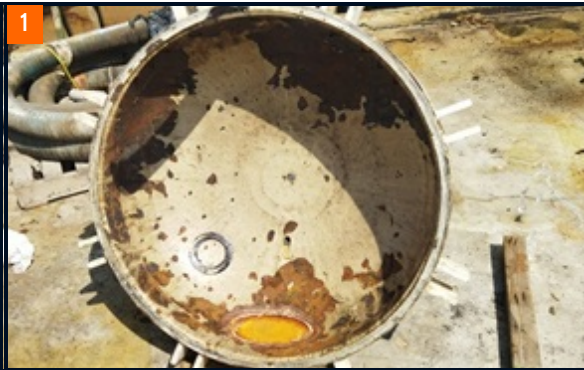
The existing lining delaminated and failed in many locations, causing localized corrosion.

1. Existing lining failed and started to show sign of corrosion
2. Old lining was removed before the repair
3. Coating during process
4. Completed application
