# REPAIR AND PROTECTION OF THE STRUT ARMS, HOUSING, AND SHAFT USING BELZONA

ID: 10014

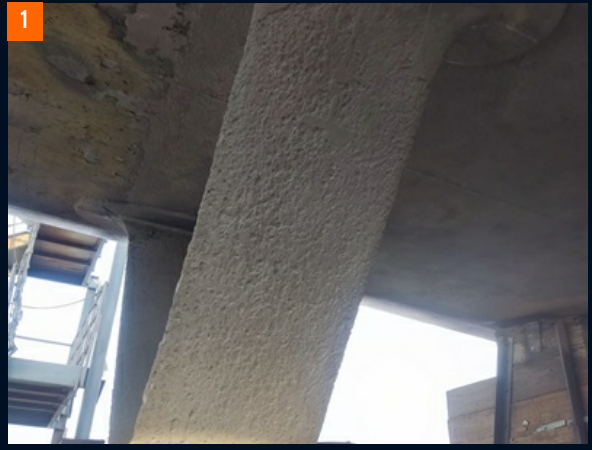
The strut arms, housing, and shaft of a marine vessel were heavily corroded due to prolonged exposure to seawater.

1. Corrosion attack was caused by prolonged exposure to seawater
2. Belzona 1111 (Super Metal) was used to rebuild and fair the pitting damage on the substrate
3. Application of the first coat of Belzona 5821
4. Application of second coat of Belzona 5821
