# BELZONA RESTORES SEAWATER COOLING PUMP IMPELLER

ID: 10016

## PROBLEM

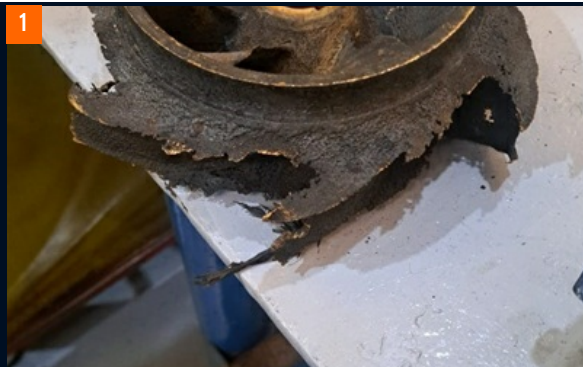
Customer had an emergency docking and sourcing a new impeller would of taken 6 to 8 weeks delivery. Impeller was severely eroded and required urgent rebuilding and coating protection from salt water as this was the vessels sea water cooling pump.

1. Damaged Impeller Received From Customer.
2. Stainless Plates Cold bonded, Clamped And Shaped To Rebuild Lost Areas.
3. Metal Plates Bonded And Rebuilt On Vanes, Top And Bottom Of Impeller.
4. Impeller Completed And Restored.

1. Received impeller, washed with SaltAway and grit blasted clean for inspection and measurement purposes.
2. Top plate made and formed to 260mm OD with ID to suit suction wear-ring OD.
