# BELZONA PROTECTS CONCRETE & DRAINAGE AREAS

ID: 10017

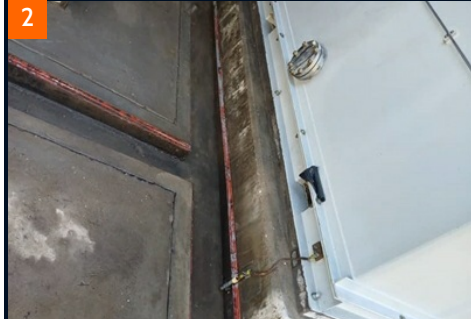
1. Contaminated areas before cleaning commences.
2. Cleaning in progress. Belzona 9111 degreaser, concrete cleaner & a water based detergent were used and then high pressure washed with clean water.
3. Coating in progress.
4. Completed work!

Contaminated areas were degreased with Belzona 9111 & concrete cleaner. They were then cleaned with a water based detergent and pressure washed with clean water. Belzona 5831 was used as a first coat followed by a top coat of Belzona 5811.
