# BELZONA SUPERWRAP II SAVES 24" EXHAUST PIPE AT STEEL MILL

ID: 10019

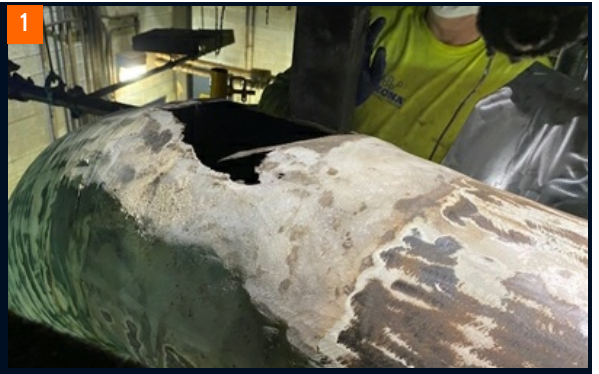
Pipe was previously repaired with fiberglass. Thin gage steel was used to make a form and bonded form with 1212 to pipe. Then we proceeded to wrap pipe (3 spirals) with 1981 Super Wrap system.

1. Holed Casing
2. Cold Bonding Former with Belzona 1212
3. Applying Belzona SuperWrap II
4. Finished Application (Consolidation Tape still needs removed)
