# BELZONA SOLUTION FOR TANK LEAK REPAIR BY PLATE BONDING METHOD

ID: 10023

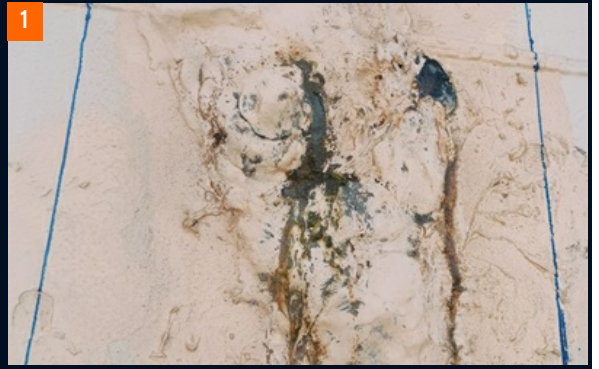
A customer encountered a significant issue with their fire water tank, where a leak had developed in the wall, resulting in a hole. This problem was causing operational disruptions and posed a risk to their processes. To minimize downtime and restore normal operations as quickly as possible, an immediate and effective repair solution was required.

1. A leak in the wall of the customer's fire water tank created a hole and disrupted operations.
2. Following cleaning, the substrate was grit-blasted, and Belzona 9611 (ES-Metal) was applied to effectively seal the leak.
3. To strengthen the repair area, Belzona 1161 (Super UW-Metal) was applied before proceeding with plate bonding.
4. Belzona 1161 (Super UW-Metal) was applied via the plate bonding method.
