# WASTEWATER TANK LINING - SPOT REPAIRS

ID: 10024

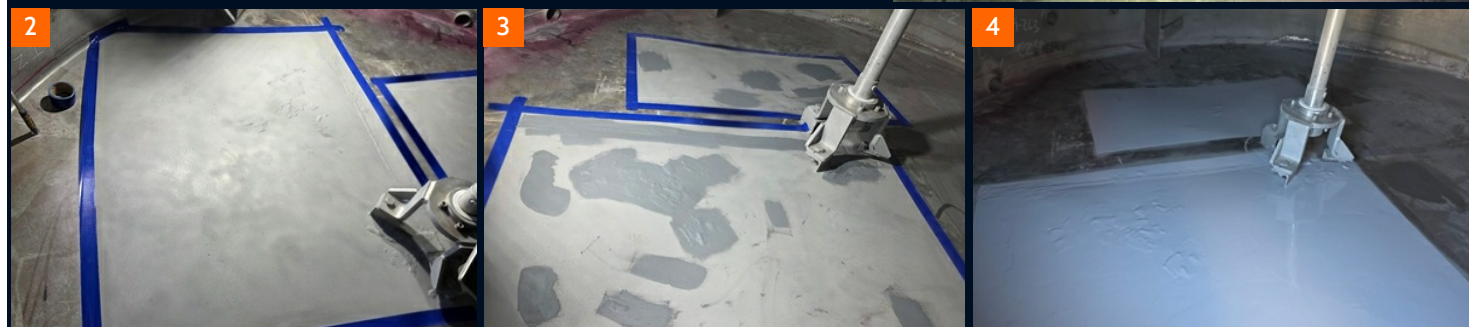
Customer had internal defects causing pitting and thin wall metal in two isolated areas on the floor of a wastewater tank. They weren't able to make weld repairs in this area because it was not possible and would not stop the corrosion. They were looking for a quick repair method because they had to use a rental tank to divert wastewater too, while this was out of service for repair.

1. Before images, with markings to identify application area
2. Abrasive Blast prep (SSPC-SP10)
3. Belzona 1121 to pit fill
4. Belzona 5892 Final Coating

After safety permitting was complete, we accessed the confined space. We marked and taped off the two defect areas that were on the floor. One was roughly 4'x4' and one was 4'x2'. Next we used emerald grit to abrasive blast the application area to achieve a rough dry clean 3mil minimum anchor profile (SSPC-SP10). We blew a dehumidifier into the asset during application to keep atmospheric conditions under control. Battery powered LED's were used to provide light inside the tank. Belzona 1121 was used to pit fill as needed. Then a two coat system of Belzona 5892 was applied. Inspection was completed per the IFU, to touch up any holidays as needed. Product was allowed to cure before return to service.
