# MULTIPLE SEA WATER LEAKS WITH STRUCTURAL REINFORCE WITH BELZONA SUPERWRAP II

ID: 10026

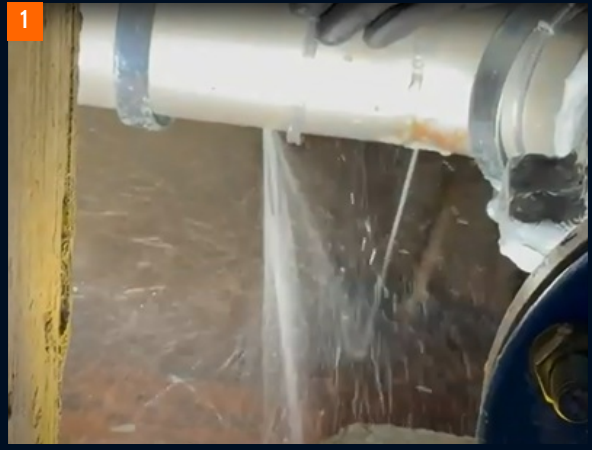
Due to the pressure that the water generated was really high so it was difficult to seal the crack.

1. This was the problem of pressure we had.
2. In this photo we show how ,after we put the plates and the jubilees with the Belzona 1212, we sealed all off with Belzona 1212 and Belzona 1161.
3. In here we show part of the Belzona SuperWrap II we did.
4. Finally in this photo we show the final look of the repair.
