# END SUCTION PUMP CASING REPAIRED WITH BELZONA

ID: 10029

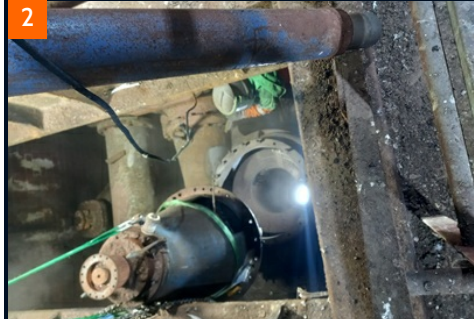
A pump used for moving waste water had eroded to the point where it had begun leaking. A temporary repair had been attempted but now a more permeant fix was required. The pump cutwater was experiencing the worst erosion.

1. Temporary leak fix
2. Casing accessed during shutdown & grit blasting underway
3. Belzona 1311 Ceramic R Metal applied internally to rebuild the hole at the cutwater
4. 2nd coat of Belzona 1321 Ceramic S Metal applied
