# PIPE SPOOL REPAIRED WITH BELZONA SUPERWRAP II

ID: 10030

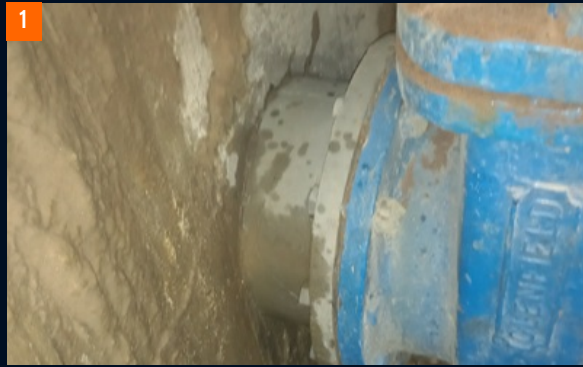
A large crack had formed in a pipe spool. This pipe was located deep within a reservoir sump & was impossible to remove without major structural works. A repair had to be put in place in-situ to prevent further leakage & to reinforce the area.

1. The leaking spool was built into the concrete sump wall - this went directly out to the reservoir.
2. Surface preparation & application of Belzona 1212
3. Layers of Belzona SuperWrap II applied
4. Repair consolidated
