# BELZONA STEMS LEAK AND REPLACES FAILED SEWAGE TANK BASE SEAL

ID: 10031

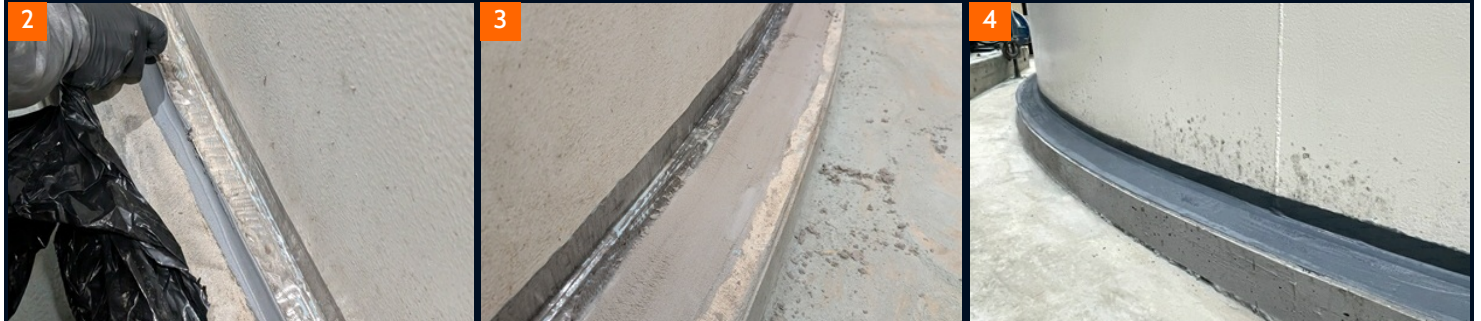
1. Tank base during surface preparation
2. Stemming the leak with Belzona 1161
3. Sealing the perimeter with Belzona 4111
4. After application of two coats of Belzona 3111 with mesh.

Sewage tank was experiencing leaks from various parts of the seal. Belzona discussed various options of repair to firstly stem the leak, seal the perimeter around the seal and application of the microporous solution.

The alternative solution was to drain the tank, lift the tank, repair, put back in place, and seal. These processes were estimated at around 250k without labor. However, Belzona did not only stem the leak in-situ but also repair the seal and was almost 8 times cheaper with labor included.

Application was carried out in accordance with Belzona Know-How System Leaflet GSS-3 and TCC-9.
