# BELZONA HELPS REBUILD TOLERANCE LOSS DUE TO MILL SCALE

ID: 10032

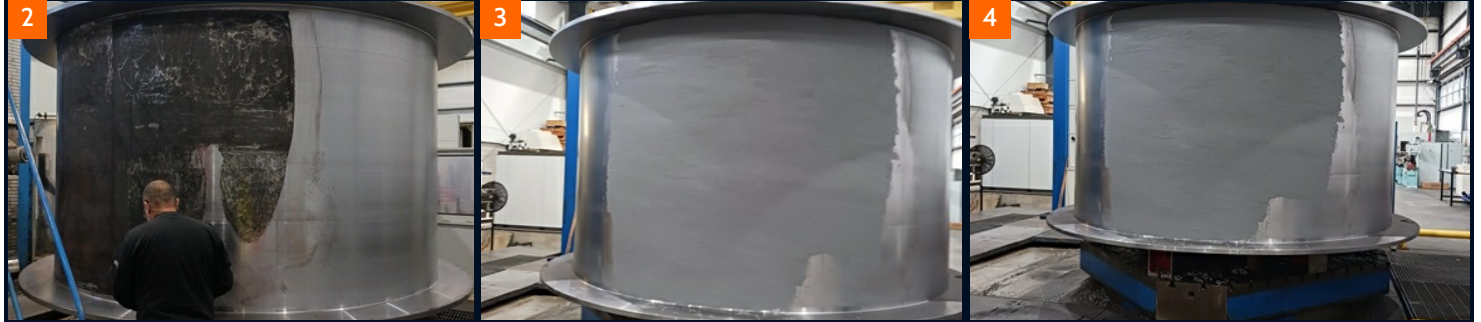
Newly fabricated cylinder experiencing reduction in diameter due to mill scale formation on some parts of the surface.

1. Cylinder with millscale
2. During surface preparation
3. After rebuilding with Belzona 1121
4. After machining

Newly fabricated cylinder experiencing reduction in diameter due to mill scale formation on some parts of the surface. Belzona was used to build the surface and machined to the required tolerance.

Surface preparation was carried out to the level of cleanliness of SSPC SP11. Then thorough solvent cleaning was done before the application of Belzona 1121 was carried out. Surface was then machined to the required diameter afterwards.
