# REBUILD AND PROTECTION OF FIREWATER PUMPS USING BELZONA

ID: 10033

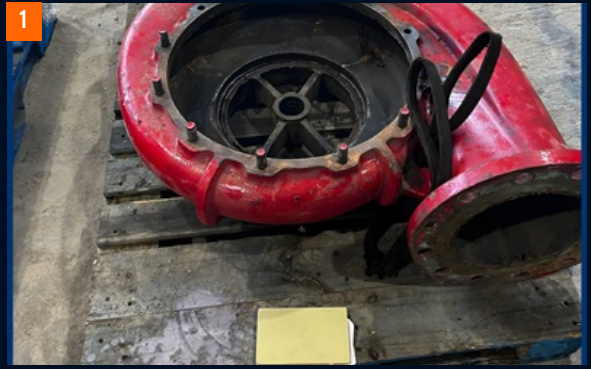
Our customer required restoration of metal loss to recover optimal flow rate and to protect the pump casing from ongoing damage caused by saltwater, sand, and debris.

1. Before Picture of the Pump Case
2. After Picture of the Pump Case
3. After picture of both Fire Water Pumps

Belzona MS, Inc. will clean pump casings with Acetone, tape off the area of repair, and start rebuilding the metal loss with Belzona 1311 R Metal.

Once The Belzona 1311 R Metal has cured enough to over coat with Belzona 1321 S Metal (Per IFU), the Technical Consultants will apply the first coat and then the second coat.
