# BELZONA SOLVES A 20-YEAR GUTTER ISSUE AT PREMIER LEAGUE FOOTBALL GROUND

ID: 10036

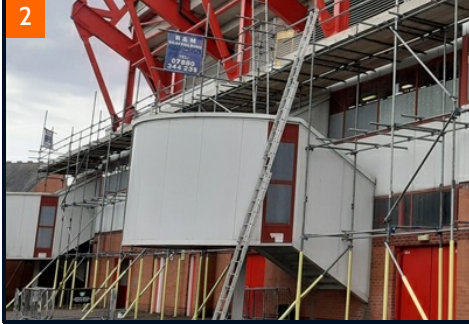
A 100m gutter had had been leaking for almost 20 years, having had many repair attempts over the time, none of which were successful. The leaking gutter would let large amounts of rain water onto the enclosed concourse below, making the surface slippery and dangerous to thousands of people when raining on match days.

1. Gutter above concourse, showing corrosion, failed joints and dropped edges.
2. Scaffolding in place during repairs.
3. New pre-fabricated gutter linings ready to be bonded over the existing failed substrate with Belzona 1161 then coated with Belzona 3111.
4. Completed relined and coating.

Out of season, it was decided to over-clad the existing gutters with pre-fabricated steel gutter lining sheets. These would be bonded onto the existing substrate using Belzona surface tolerant epoxies, prior to overcoating with Belzona flexible membrane.
