# BELZONA SEALS DIFFICULT TO REACH ROOF VOID

ID: 10039

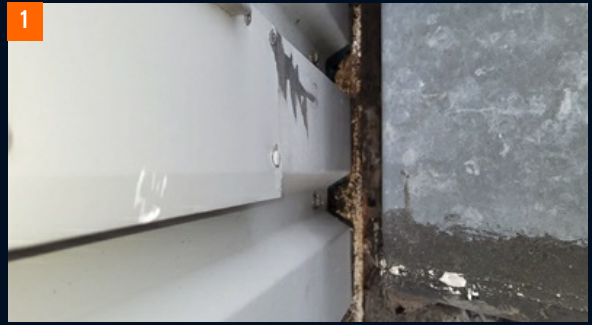
Leaks and issues were identified, originally emanating from an area of the roof which was extremely difficult to access, due to its size, depth and position

1. A repair was needed to be made at a depth, almost out of each
2. It wouldn't have been possible to offer a solution any other way than a flexible membrane. Belzona 3131 was chosen
3. Belzona 3131 was the ideal choice for this difficult task
4. All complete with the deep void completely sealed

All dirt and debris were removed

A coat of 3921 was applied to the area, followed by 2 coats of Belzona 3131 with 9361 reinforcing sheet in place

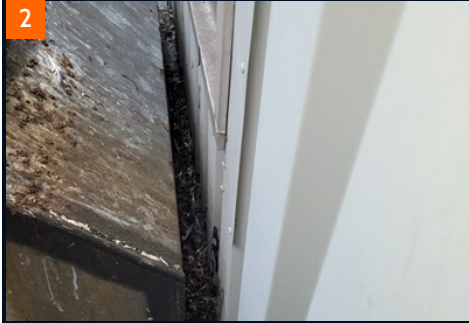
Due to the position and situation of the leaking joints, there was no other way to complete a repair other than using a flexible membrane. Due to the experience the client has had with previous Belzona products, it was an easy choice for them to agree to the proposed solution
