# A GOOD NIGHT WITH BELZONA

ID: 1004

Manholes on the street were causing a lot of noise due to uneven cover seat. Local people call them "Singing Covers".

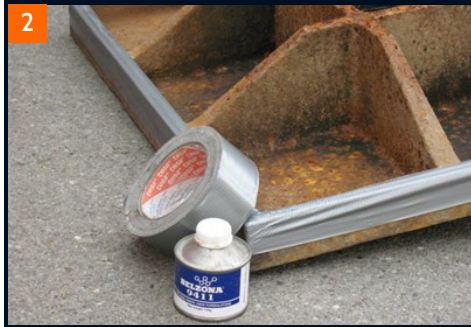
1. Manhole
2. Applying Duct tape and Belzona 9411
3. Rebuilding manhole cover seat with Belzona 1111
4. Manhole in place and position marked

The manhole seats were roughened and then degreased. Cover plate ends were protected with Duct tape and Belzona® 9411. Belzona® 1111 was used to rebuild the manhole cover seat in accordance with Belzona Know-How System Leaflet GSS-8.
