# ENGINEERING PLANT ROOF BENEFITS FROM THE BELZONA ROOF TREATMENT

ID: 10041

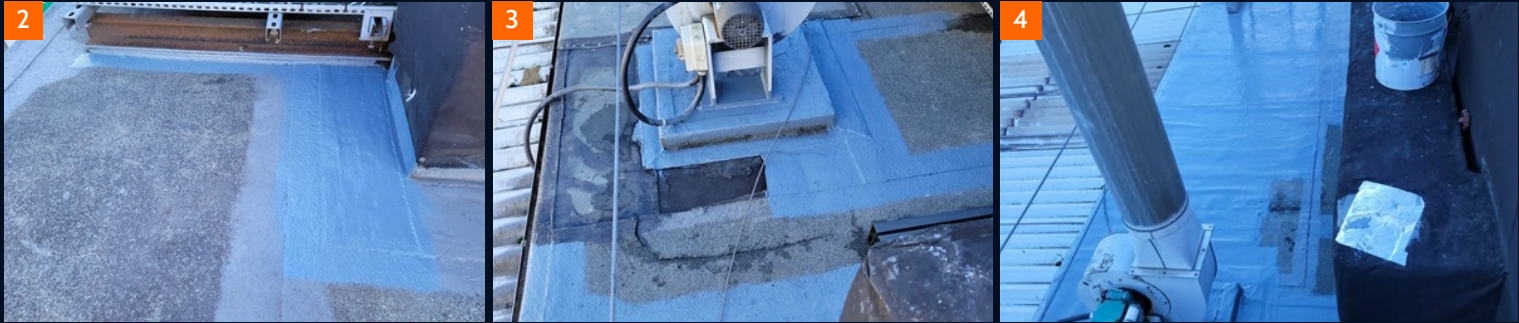
Numerous leaks were causing difficulties in a large engineering workshop. Equipment and stock were becoming compromised by continuous water ingress.

1. Close up of a typical example of the numerous failures found on the engineering workshop roof.
2. Completing detailed works around one of the many service assets which populated the roof.
3. Further detailed preparatory works before final coats are applied.
4. All works completed, including a 200 mm drop down all sides to completely encapsulate the roof.

All the existing roof was cleaned and pressure washed. Attention was given to all intricate areas and difficult interfaces. Belzona 3921 was used to condition any non-porous substrates where the Belzona 3131 was to be applied. 2 coats of Belzona 3131 were finally applied to completely encapsulate the roof area.
