# BELZONA TACKLES POSITIONAL REPAIRS TO MACHINE DAMAGED WALL

ID: 10045

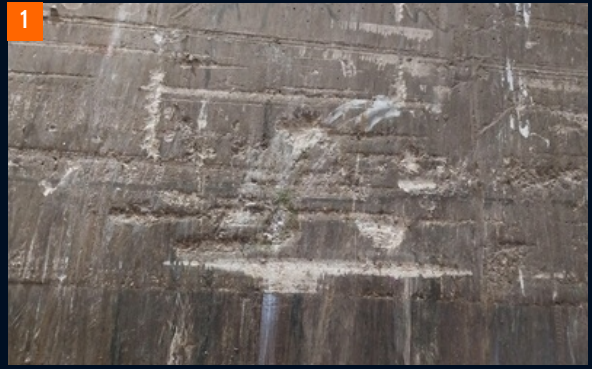
A large wall had continued to sustain damage through impact with loader shovels and payloaders in the tipping hall of a large Energy from Waste site. It was decided to use Belzona MagmaBuild 4141 as a solution and offer sizeable repairs

1. Closer view of the damage sustained by the payload bucket impact
2. Colleagues setting about the repair to the wall
3. Training taking place for the in-house colleagues to learn the application process
4. Finishing touches to complete the application training

The wall was prepared by brushing, ensuring that all loose and friable materials were removed

The target areas were coated with Belzona 4911 TX Conditioner

The Belzona 4141 was mixed as per the IFU and applied by gloved hand, building up the volume until being troweled by a finishing trowel
