# BELZONA SAVES BOW THRUSTER TUNNEL FROM ELECTROLYSIS

ID: 10047

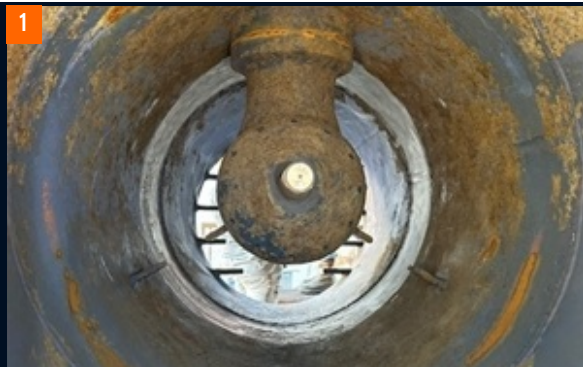
Customer had a large government ferry 1-yr old that was suffering from electrolysis in the bow thruster tunnel.

1. Bow thruster tunnel suffering from pitting due to electrolysis.
2. Bow thruster tunnel blasted to required SSPC-SP10.
3. Belzona 1311 used to fill all pitting in tunnel.
4. Job completed after 2nd coat of Belzona 1321 coating.
